Name of Dam: Lake Hottel Dam

Location: Caroline County, Commonwealth of Virginia

Inventory Number: VA 03334

PHASE I INSPECTION REPORT

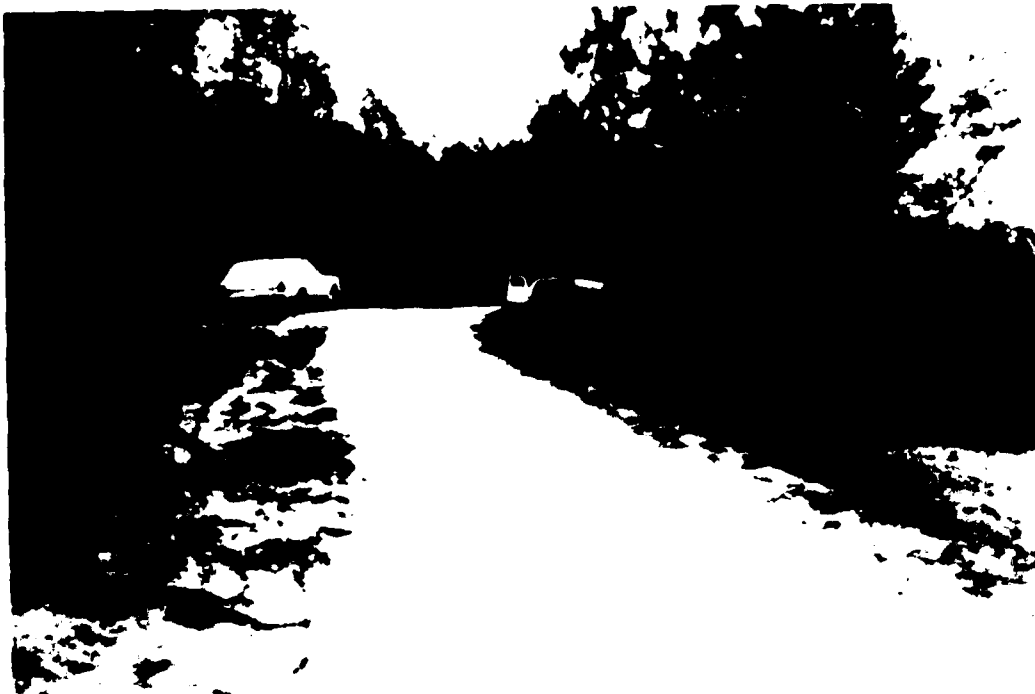
The approach area to the emergency spillway is broad and unobstructed. The approach area consists of natural ground and reservoir bottom with little vegetation. The discharge channel is not well defined downstream of the crest. A dirt roadway providing access to the dam and reservoir passes through the emergency spillway and ends at the upstream edge of the reservoir.

PHOTO 6. Emergency Spillway Channel (Looking Upstream)
